COMMISSION OF  
INQUIRY INTO THE  
AIR ONTARIO CRASH  
AT DRYDEN, ONTARIO

Final Report

Technical  
Appendices

The Honourable Virgil P. Moshansky  
Commissioner

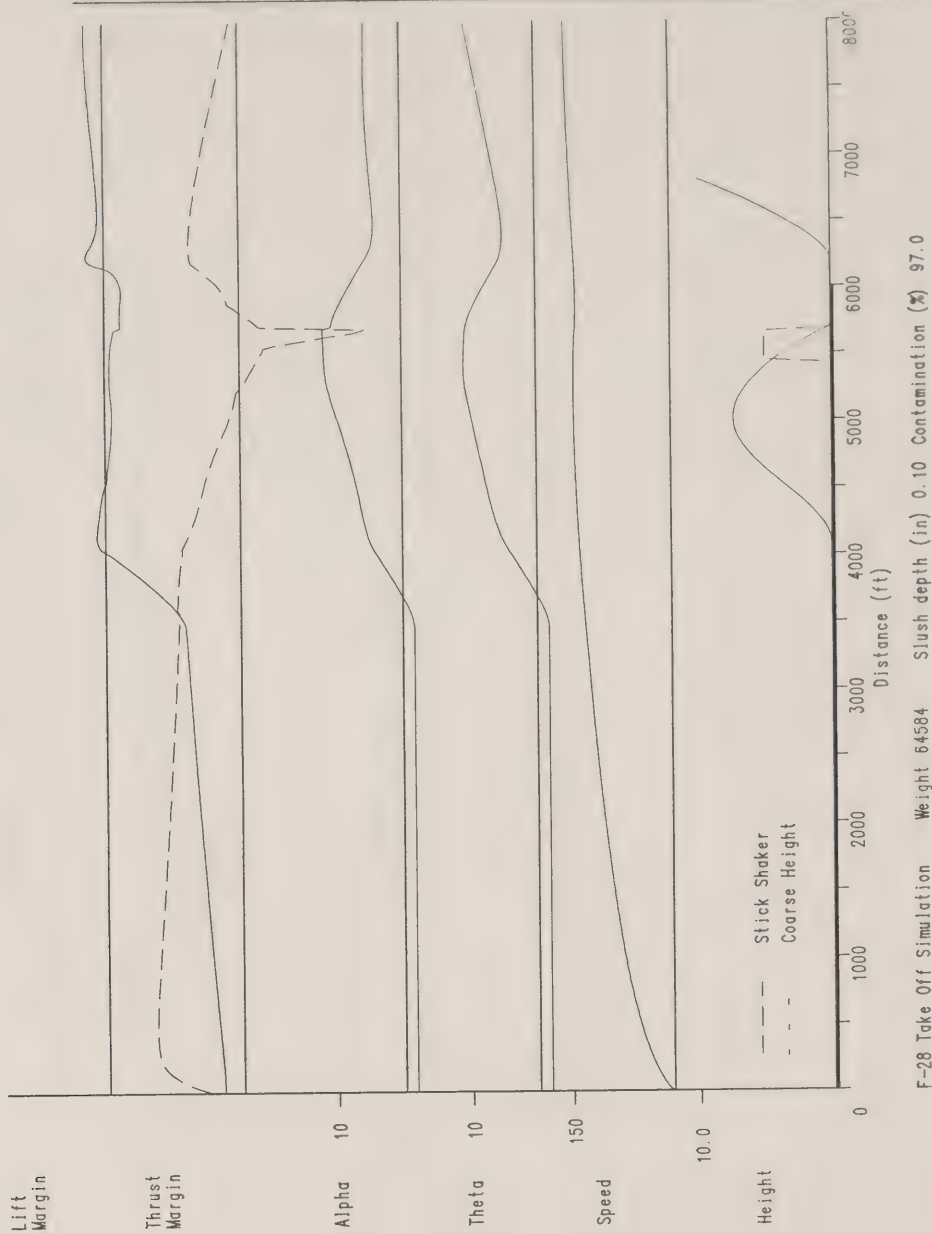
Figure 10a Second Lift-Off Following Hop

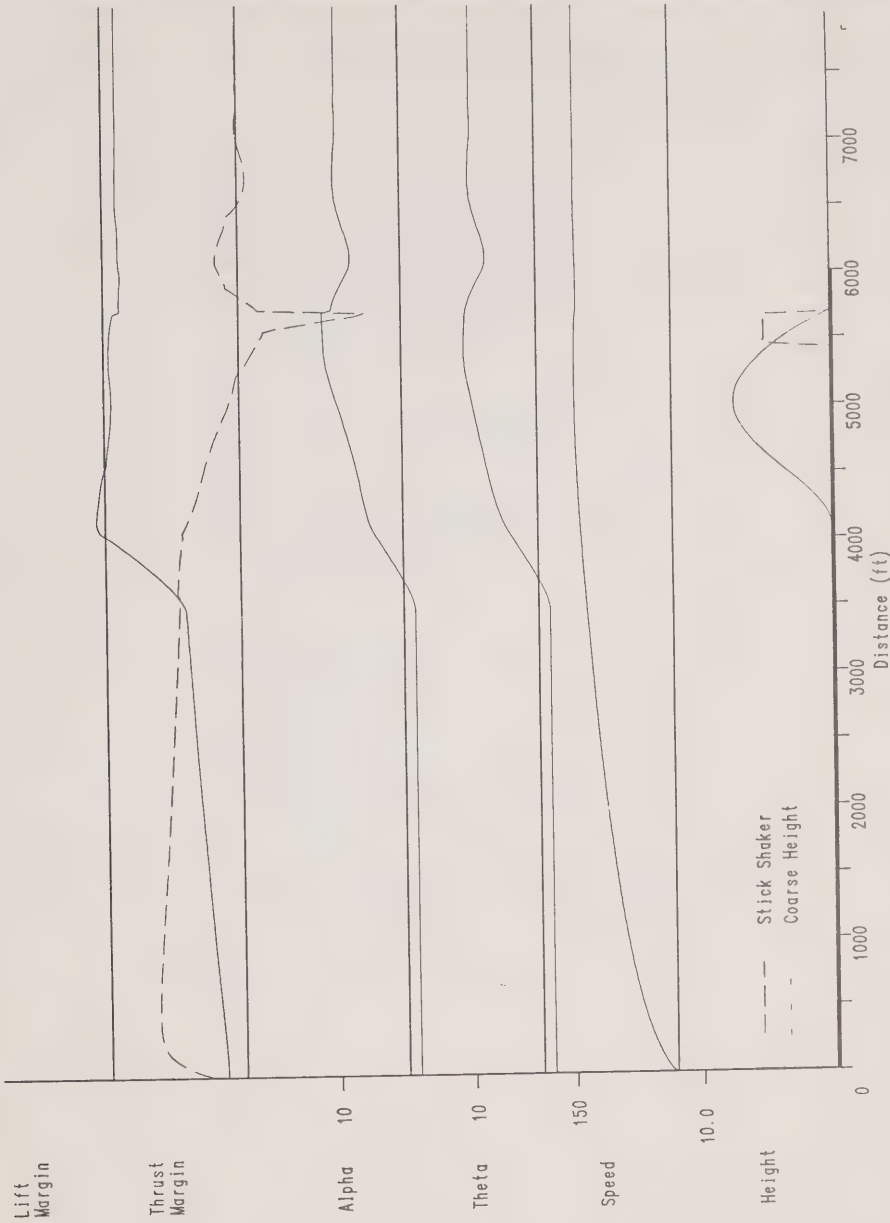
F-28 Take Off Simulation    Weight 64584    Slush depth (in) 0.10    Contamination (%) 97.0

Figure 10b Slight Change in Technique Causes Overrun

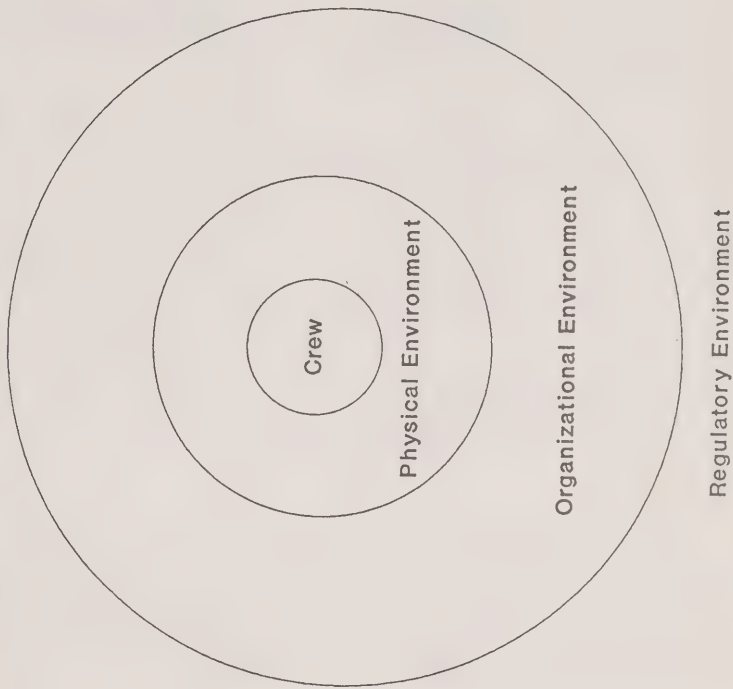
**Figure 1. Flightcrew Environments:  
Factors Influencing Behaviour**

The results of this analysis suggest that the concatenation of multiple factors from each category allowed the crew to decide to take off with contaminated wings. According to this view, no single factor taken in isolation would have triggered the crew's behaviour prior to and during take-off, but in combination they provided an environment in which a serious procedural error could occur. This array of contributory influences without a single, proximal cause warrants classification of the accident as a system failure. The analysis will attempt to define these influences and their inter-relationships. Observations and suggested counter-measures will also be provided.
